**DIVISION OF RATEPAYER ADVOCATES  
CALIFORNIA PUBLIC UTILITIES COMMISSION**

**Report on Additional Information  
Concerning the Proposed  
Big Bear Boulevard Undergrounding Project  
of the  
Bear Valley Electric Service Division**

San Francisco, California  
October 2, 2013

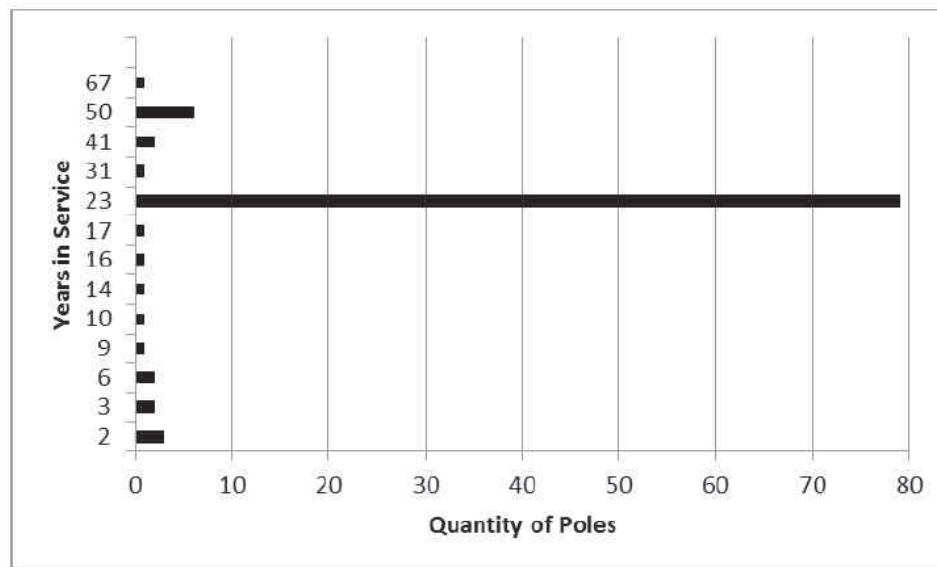
Figure 1 Age of Poles in BVES Study

the 99 poles with remaining pole strength data available fell into the 70% - 85% remaining strength range (i.e., Range 2). Furthermore, 74 of the 99 poles, representing nearly 75% of the poles in the study, were installed between 20 – 25 years ago. Shown below in Figure 1 is the distribution of the poles in this study in accordance with the number of years they have been in service.
